**NOSSA-TR-2004-001** 22 January 2004  
Ordnance Environmental Support Office  
Technical Report

# **Field Demonstration of In Situ Perchlorate Bioremediation at Building 1419**

By Randall J. Cramer and Carey Yates  
Indian Head Division  
Naval Surface Warfare Center

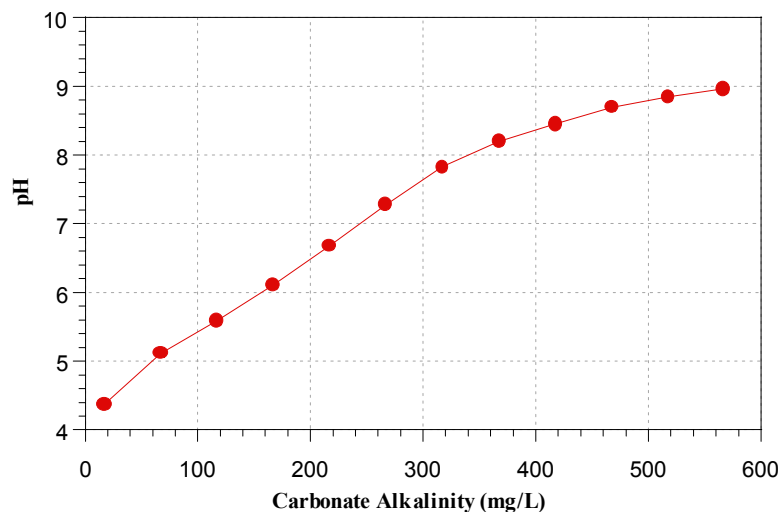
**Figure 1. Carbonate Titration Curve for Sediment Slurries from the Building 1419 Site**

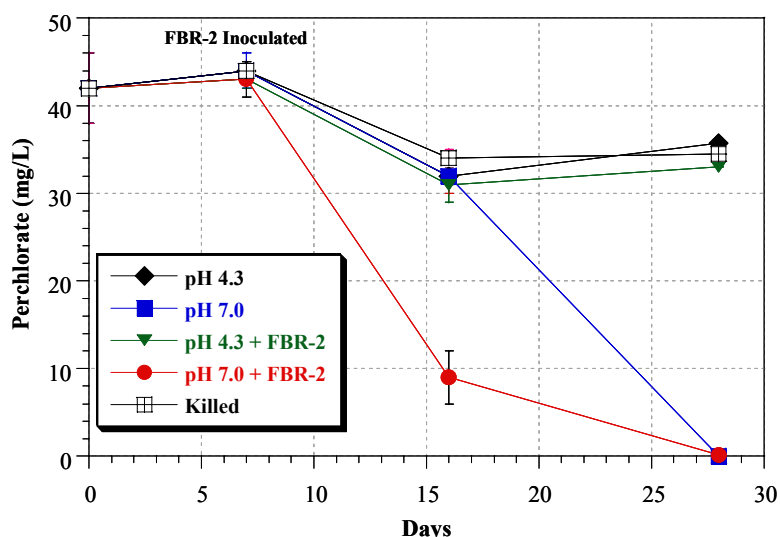
The perchlorate levels in the samples at pH 4.3 did not decline appreciably during the study, regardless of whether the samples were bioaugmented (Figure 2). Conversely, the samples in which the pH was increased to 7.0 all showed perchlorate biodegradation. Perchlorate levels in samples receiving *Dechlorospirillum* sp. FBR2 declined from 43 to 9 mg/L from day 7 to day 16, and then to 0.16 mg/L by day 28. The perchlorate concentrations in samples that were brought to pH 7.0 but not augmented with the culture declined more slowly, but perchlorate was below detection by day 28 of the experiment. Thus, the data suggest that low pH was inhibiting perchlorate degradation in the hog-out site samples. It is interesting that indigenous perchlorate-degrading microorganisms could be stimulated to degrade the anion at a pH of 7.0 but not at a pH of 4.3. These bacteria are obviously able to survive at the low pH, which occurs naturally at this site, yet appear not to degrade perchlorate at this pH. The results suggest that (1) there may be a pH below which perchlorate biodegradation is physiologically inhibited; or (2) some other geochemical factor (e.g., heavy metal toxicity or trace metal unavailability) prevents perchlorate biodegradation at low pH.

**Figure 2. Influence of pH on Perchlorate Degradation in Aquifer Microcosms from the Building 1419 Site**

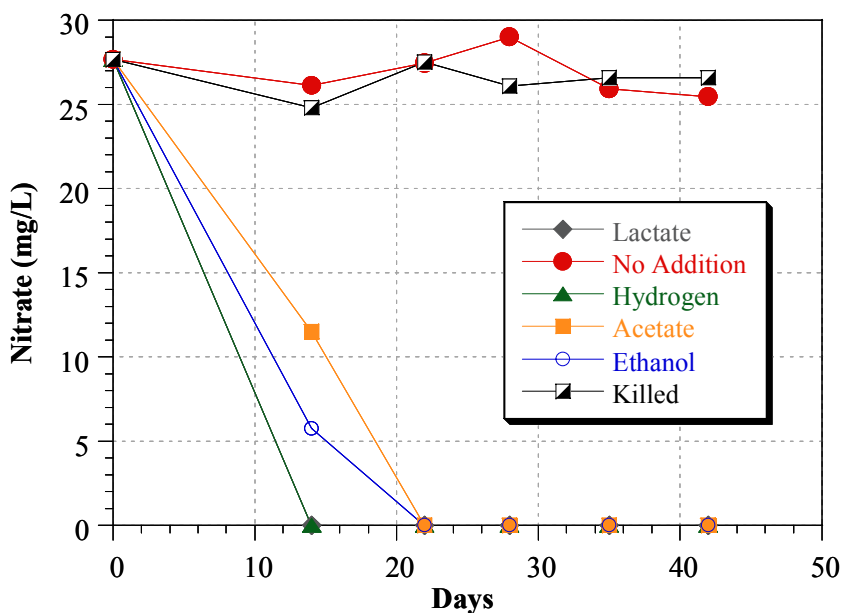
In the samples adjusted to pH 7.3, nitrate was biodegraded to below detection (< 2 mg/L) within 22 days in samples amended with ethanol, acetate, lactate, or hydrogen gas (Figure 3). Nitrate biodegradation was not observed in samples that did not receive an electron donor or in killed control samples. Biodegradation of perchlorate was apparent in pH-adjusted microcosms amended with lactate (Figure 4). Perchlorate concentrations declined from a high of 181 mg/L at day 14 to less than 14 mg/L by day 61 (the last sample collected) in the microcosms receiving lactate. The pH-adjusted microcosms receiving acetate, ethanol, and hydrogen gas did not show appreciable perchlorate reduction during the course of the study. Perchlorate levels also did not decline in microcosms without added electron donor or in killed controls.

**Figure 3. Influence of Different Electron Donors on Nitrate Biodegradation in Buffered Site Samples**

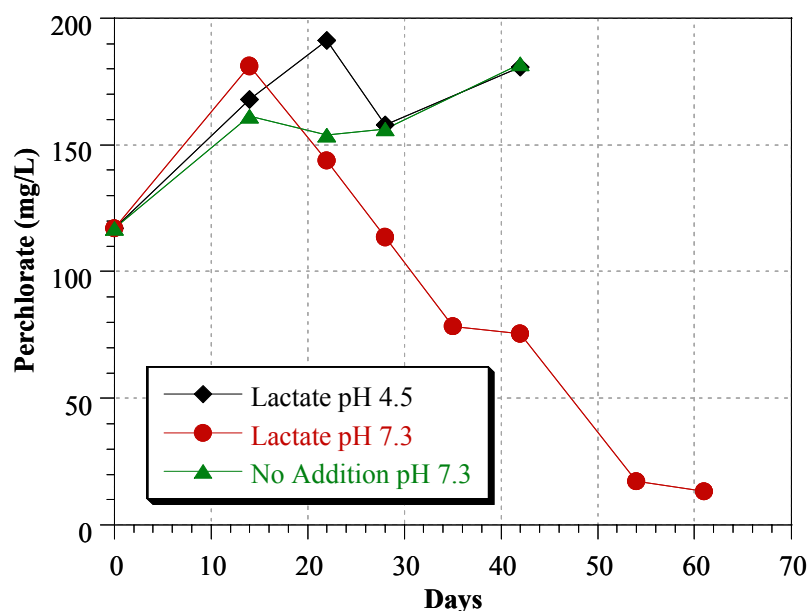
The initial perchlorate levels in the microcosms at day 0 averaged 116 mg/L, and the starting nitrate concentration was 27.7 mg/L. The level of perchlorate in the microcosms increased from 116 mg/L at day 0 (immediately after slurry preparation) to approximately 170 mg/L at day 14. This increase was consistent among samples and appears not to reflect an analytical error or inconsistency. Therefore, it is likely that this increase reflects perchlorate desorbing from the site sediments into solution. There was no degradation of perchlorate or nitrate in any of the microcosms that remained at pH 4.5, irrespective of the type of electron donor added (data not shown). This finding confirms results from previous studies conducted at Shaw Environmental with samples from IHDIV and the Longhorn Army Ammunition Plant which suggest that low pH (< 5.7) is inhibitory to biological perchlorate reduction. The data also suggest that the low pH is inhibitory to biological nitrate reduction at the hog-out site.

**Figure 4. Perchlorate Levels in Aquifer Microcosms Receiving Lactate (pH 4.5 or 7.3) or No Electron Donor**

The data from this microcosm experiment generally support previous laboratory studies conducted by Shaw Environmental and IHDIV from several sites across the country. The data show the following:

- (1) Naturally occurring bacteria capable of degrading perchlorate are present in the test plot location.
- (2) These bacteria can be stimulated to degrade perchlorate using lactate as an electron donor.
- (3) Adjustment of pH from 4.5 to neutrality will be required for perchlorate reduction to occur.

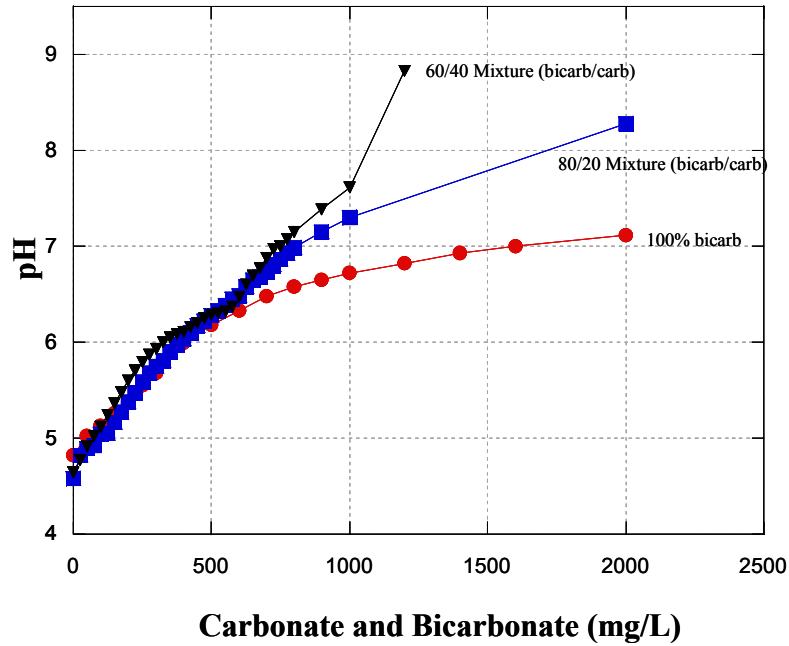
The titration curves for bicarbonate and two carbonate/bicarbonate mixtures in the aquifer sediment slurries are provided in Figure 5. The quantity of buffer required to reach a pH of 7.0 was appreciably higher when bicarbonate alone was used (1,600 mg/L) compared to a 80/20 mixture or a 60/40 mixture of bicarbonate/carbonate (800 mg/L and 750 mg/L, respectively). However, the pH of the aquifer sediments increased only gradually beyond 7.0 with continued amendment with bicarbonate only. The pH of the sediment slurry was only 7.12 after addition of 2,000 mg/L of bicarbonate (the highest dose tested). The pH of aquifer samples receiving 20% carbonate and 80% bicarbonate reached 7.0 after addition of 800 mg/L of buffer, and the pH achieved after addition of 2,000 mg/L was 8.3. The 60/40 mixture of bicarbonate/carbonate brought the sediment slurry to a pH of 8.8 after addition of 1,200 mg/L. The pH response of site groundwater amended with the three different buffer solutions is presented in Figure 6. After addition of 2,000 mg/L of each buffer, the pH of the groundwater was 8.95 for bicarbonate only, 9.42 for a 90/10 mixture, and 9.60 for an 80/20 mixture of bicarbonate/carbonate, respectively.

**Figure 5. Influence of Bicarbonate/Carbonate Mixtures on pH of Sediment Slurries from the Demonstration Area**

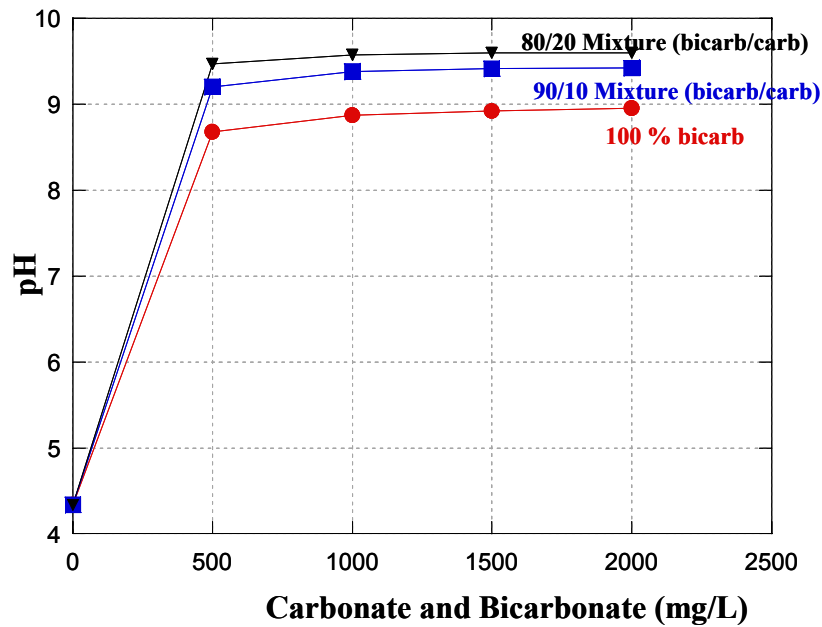
**Figure 6. Influence of Bicarbonate and Carbonate/Bicarbonate Mixtures on Groundwater pH**

The equilibrium chemistry for carbon dioxide, bicarbonate, and carbonate in natural waters is complicated and is affected by the geology and geochemistry of the system. Based on equilibrium curves published for carbon dioxide/bicarbonate/carbonate, the maximum pH in an aqueous solution containing only bicarbonate should be approximately 8.5 to 9.0 (Wetzel, 1975). The final pH of the site groundwater amended with bicarbonate only was within this range. As the ratio of carbonate/bicarbonate increases, pH will increase accordingly, exceeding 12 when carbonate only is in solution. Thus, while carbonate is more effective than bicarbonate for neutralizing acidity, the potential for increasing aqueous pH to levels beyond those which are optimal for the activity of perchlorate-reducing bacteria (6.0–8.0) is also higher when using a carbonate solution compared to bicarbonate. These factors must be taken into account when attempting to buffer an acidic aquifer. Based on these results and the expected consumption of alkalinity during aquifer buffering, a concentrated solution (6.67%) of 80% bicarbonate and 20% carbonate was initially chosen for the concentrated buffer to be used during the demonstration. The pH of the water in the monitoring wells was closely monitored to determine the effectiveness of buffering, and adjustments were made to the buffer mixture based on these data.

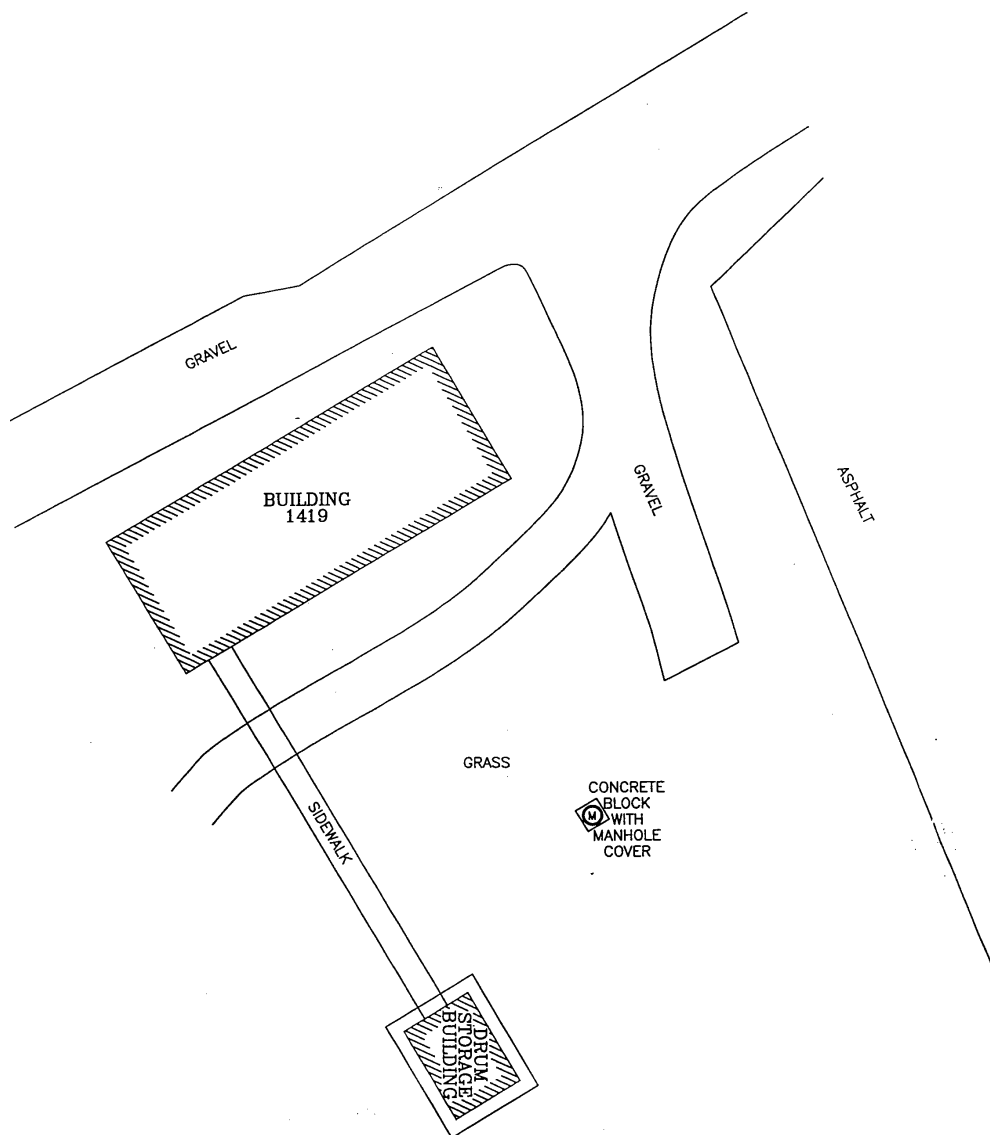
**Figure 8. Site Plan View**

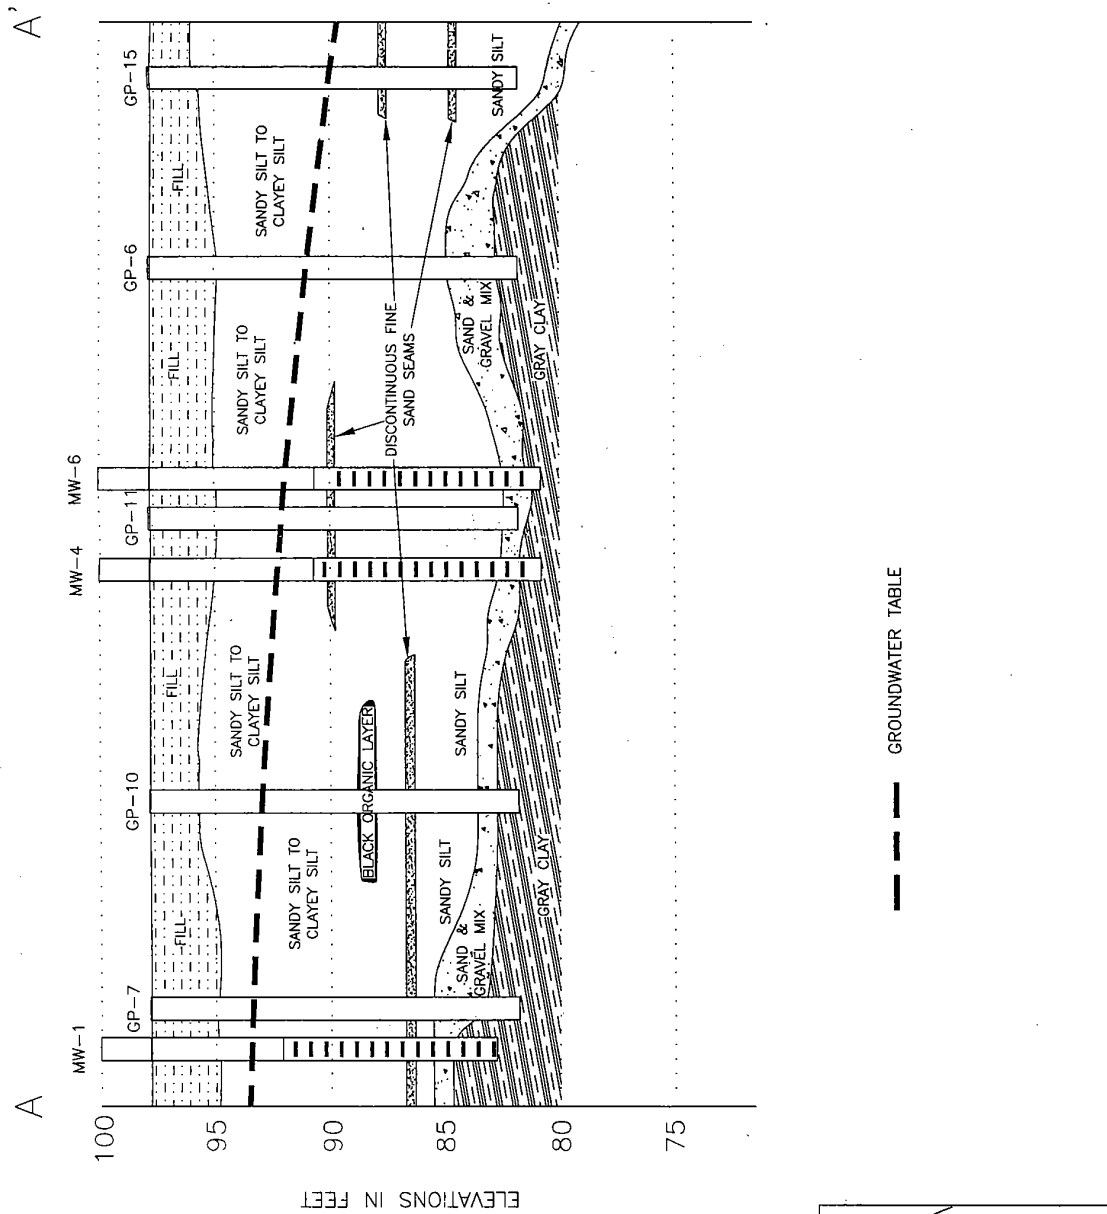
**Figure 11. Geologic Cross-Section A-A'**

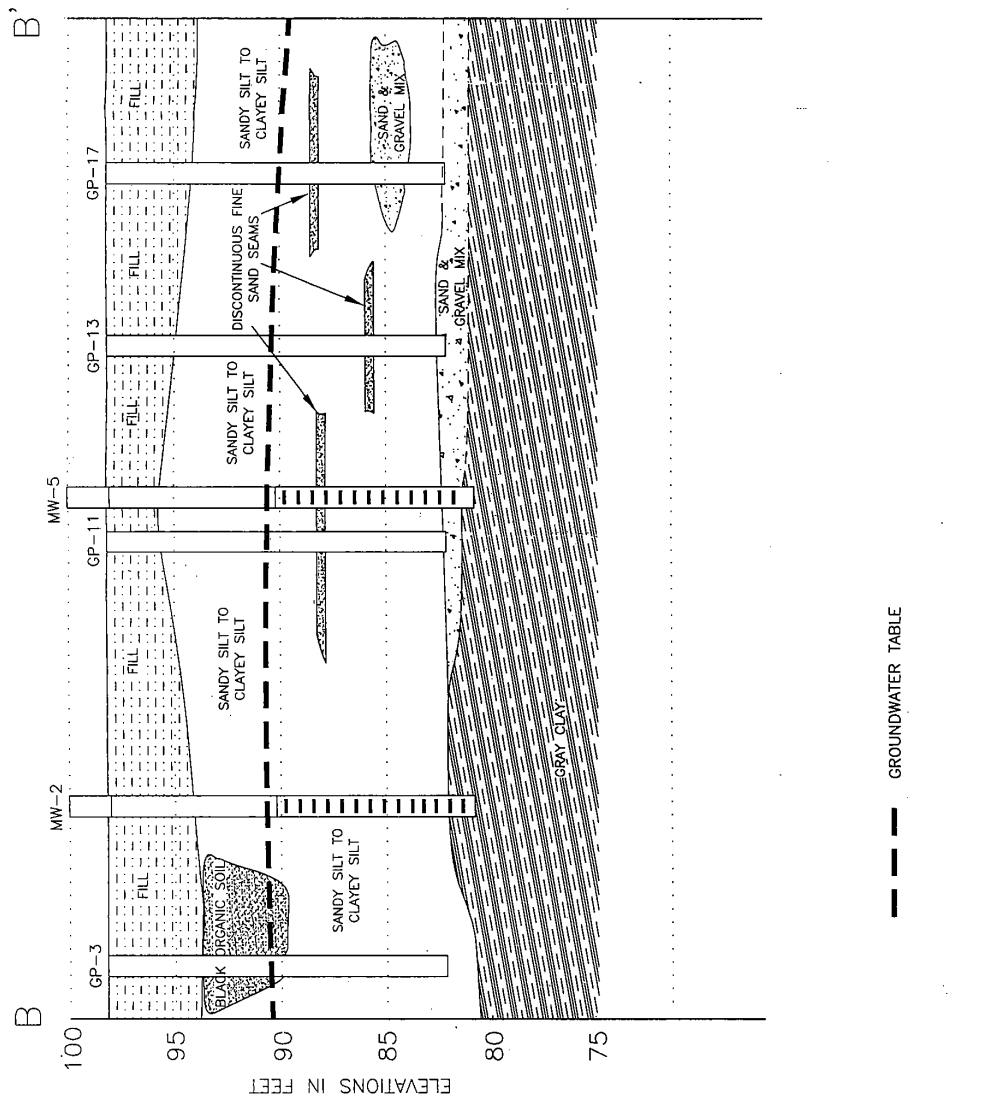
Figure 12. Geologic Cross-Section B-B'

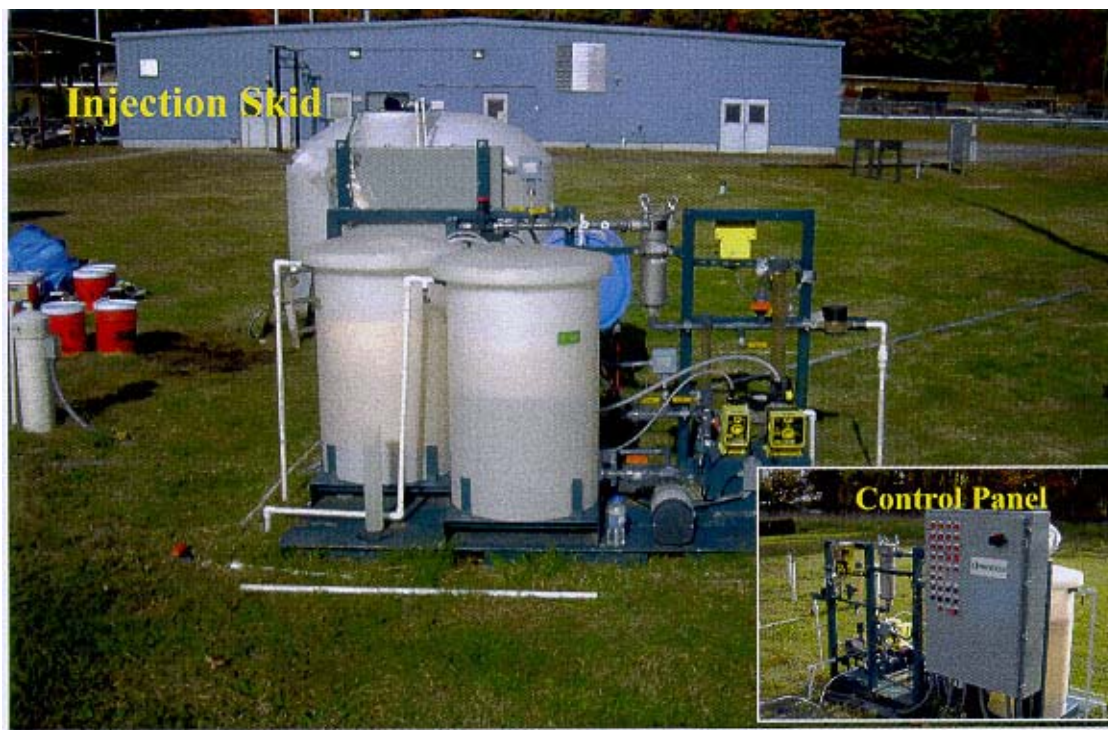
An injection skid was designed to be integrated with the wells. The injection skid had separate transfer tanks, injection pumps, flow meters, and associated valves for the control and test plots. In addition, the test plot had two metering pumps installed to inject a pH solution and an electron donor-reagent to promote optimal aquifer conditions and stimulate biological activity. The injection skid was located between the control and test plots.

**Figure 16. Control Panel and Treatment Skid**

The pH buffer tank (1,500-gal polyethylene tank) was filled with groundwater extracted from this site. Site water was used to prepare the buffer to ensure that there was no dilution in perchlorate levels in the test plot during buffer injection. A special line was run from the extraction wells to the buffer tank so that water could be periodically diverted to fill the tank. All piping runs and controls were configured to minimize the potential for aeration of the recirculated groundwater. The buffering agents were food-grade sodium bicarbonate and sodium carbonate (see the “System Operation” section). Once the pH buffer tank was filled, the extracted groundwater was diverted to the injection skid and re-injected in the test and control plot areas. The pH buffer tank was connected to the metering pump by 1/2-inch PVC pipe. IHDIV personnel installed the electrical service at the site. A 60-A, 230-V, single-phase service was provided for use on this project. The injection skid and the recirculation cells are shown in Figures 16 and 17.

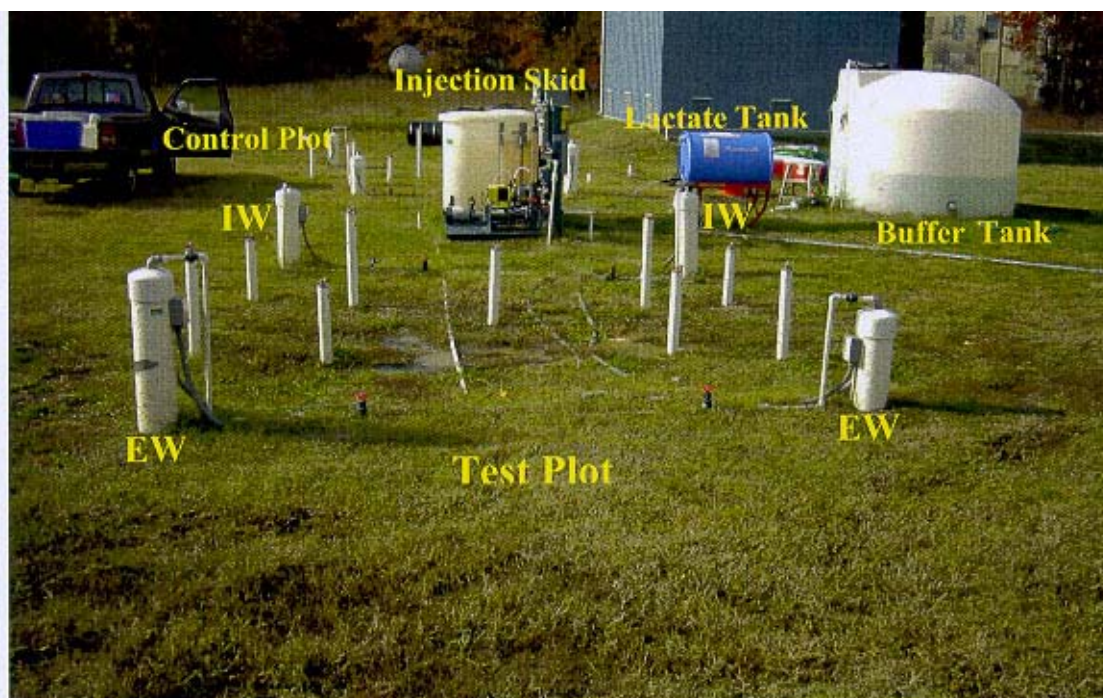
**Figure 17. Recirculation Cells and Components**

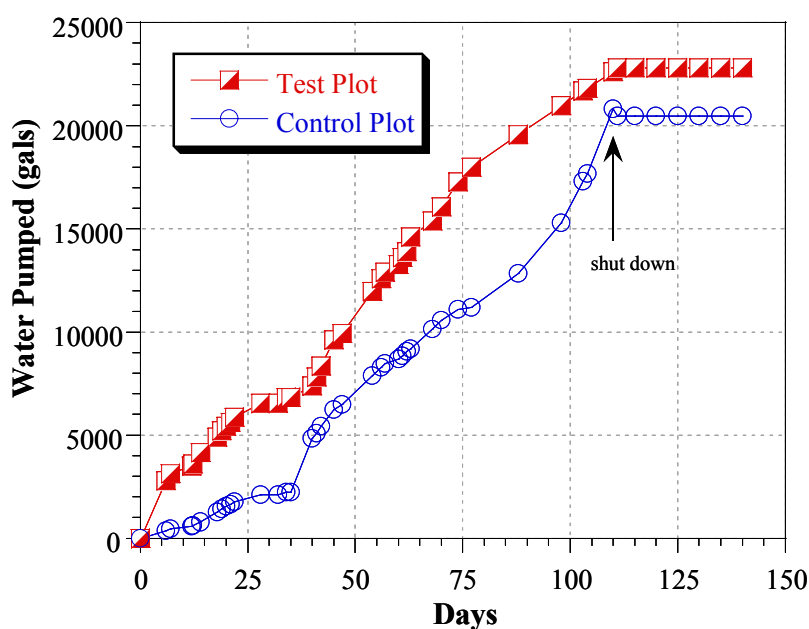
appreciably higher than through the control plot. During this period, approximately 6,500 gal of water were pumped through the test plot compared to 2,100 gal for the control plot. This difference was based on the yield of the aquifer formation in each of these zones. After this time, however, the rate of pumping of the two plots was reasonably similar, as can be seen from the slope of the curves in Figure 18. Increased rainfall in the late summer and early fall, including more than 2.3 inches on 28 August, caused significant aquifer recharge and subsequently increased pumping rates during the demonstration. On 11 November 2002, the groundwater injection rates could no longer be sustained due to the high water table resulting from rainfall in October and early November (nearly 6 inches of rain fell during this period). The system was shut down at this time, which was near the end of the planned period for the demonstration. Rainfall data at IHDIV during the course of the demonstration are provided in Appendix C. Over the course of the entire demonstration, approximately 180 gal of water per day was recirculated through each cell.

**Figure 18. Groundwater Volumes Recirculated through the Test Plot and the Control Plot During the Demonstration**

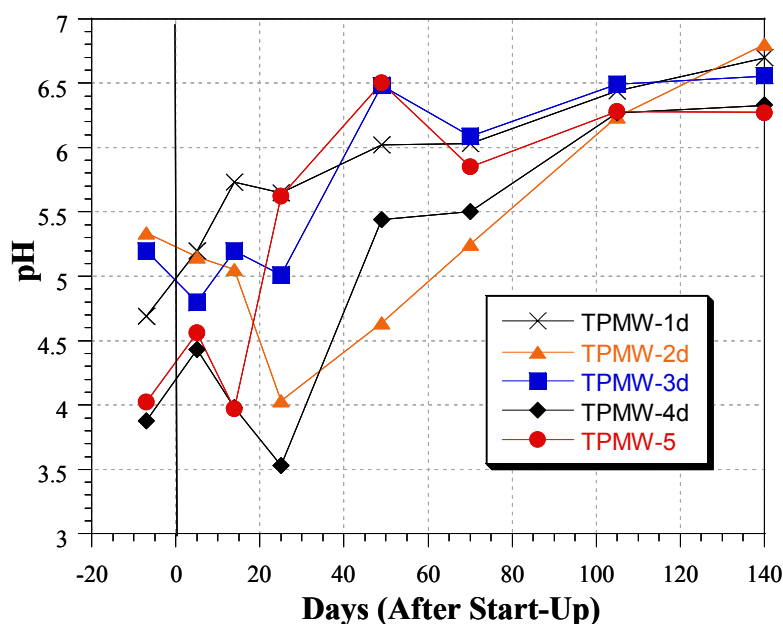
The pH of groundwater in the test and control plots was measured using a field probe (YSI 600XL water quality meter) during sample collection and in the laboratory by EPA Method 150.1. Alkalinity was measured by titration according to EPA Method 310.1. The pH of the groundwater in each of the nine TPMWs was observed to increase significantly during the course of the 140-day demonstration (Figures 19 and 20 and Table VI). For example, the pH in TPMW-5 increased from 4.02 seven days before the start of the demonstration to 6.28 at day 105, just before the system was shut down. At day 140, 4 weeks after the injection system was shut off, the pH in this well remained at 6.27. Conversely, there was no appreciable and consistent change in the pH of the control plot monitoring wells (CPMWs) during the active demonstration (Figure 21 and Table VII).

**Figure 19. pH Values in Deep TPMWs During the Field Demonstration**

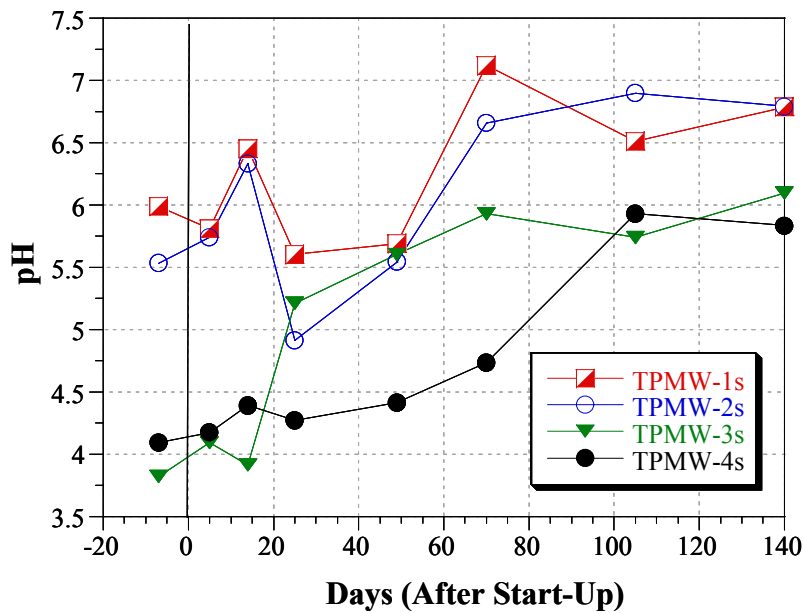
**Figure 20. pH Values in Shallow TPMWs During the Field Demonstration**

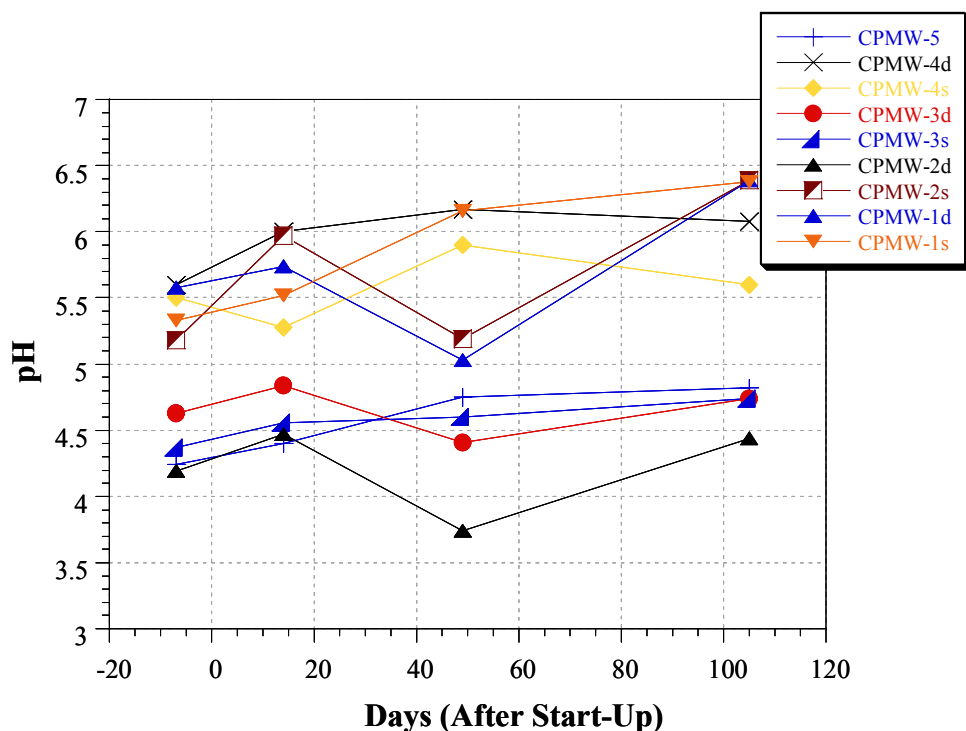
**Figure 21. pH Values in the CPMWs During the Field Demonstration**

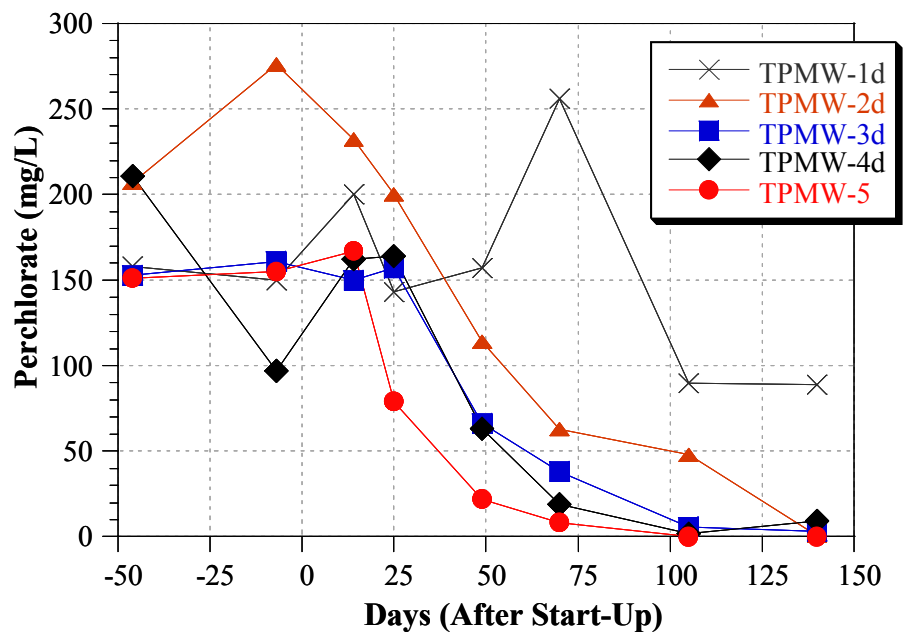
Perchlorate in groundwater was analyzed according to EPA Method 314.0. Perchlorate levels throughout the test plot showed a steady decline during the 5-month field demonstration (Figures 22 and 23 and Table XI). During the two baseline sampling events (69 and 7 days before system startup), perchlorate levels ranged from a low of 72 mg/L in well TPMW-3s to a high of 276 mg/L in TPMW-2d. The average perchlorate level in the test plot was 171 mg/L on 10 May (69 days prior to startup) and 174 mg/L on 18 July (7 days prior to startup). By the end of the 20-week demonstration, perchlorate levels in two test wells (TPMW-1s and TPMW-2s) were below the practical quantitation limit (PQL) of 5 µg/L, one well was less than 20 µg/L (TPMW-5), and two additional wells were less than 1 mg/L. The reduction in aqueous perchlorate from the start of the demonstration was in excess of 99% for each of these wells. Of the remaining four wells in the test plot, two displayed perchlorate concentrations of less than 3.7 mg/L (TPMW-3s and TPMW-3d) at the end of the demonstration, and one (TPMW-4d) was less than 10 mg/L. However, perchlorate in groundwater from TPMW-4d had reached levels as low as 2 mg/L during system operation. The percent reduction in perchlorate in each of these wells exceeded 95% from the start to the end of the demonstration. The only well in which perchlorate levels did not decline precipitously during the demonstration was TPMW-1d. Perchlorate levels fell by only 43% in this well, ending at approximately 90 mg/L after 140 days. As previously noted, this well consistently had the lowest concentration of electron donor, and the highest residual nitrate levels during the demonstration. It is likely that the flow pattern in the vicinity of this well continually introduced water from outside of the treatment area.

**Figure 22. Perchlorate Levels in Deep TPMWs During the Field Demonstration**

The data from the demonstration clearly show that the addition of buffer and electron donor to the test plot stimulated the microbial reduction of perchlorate in the aquifer. Losses of perchlorate to dilution or any other abiotic process would have been observed in both plots. The data also show that even in an acidic aquifer with extremely high perchlorate levels, in situ biological reduction can effectively reduce perchlorate concentrations to less than 5 µg/L in a reasonably short period. Although a treatment level of 5 µg/L for perchlorate was not achieved in every well, a reduction in perchlorate levels exceeding 95% was observed in eight of the nine TPMWs, including those screened in the shallow, less conductive zone in the aquifer. Based on the trends of perchlorate removal observed during the demonstration, it is likely that many of the other TPMWs would have reached non-detect levels of perchlorate with additional time of system operation.

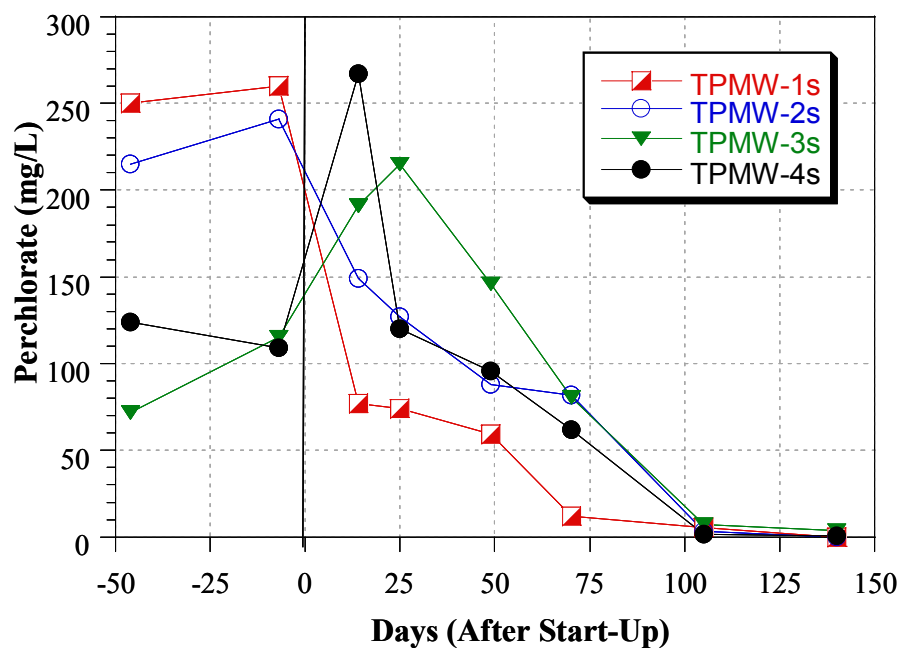
**Figure 23. Perchlorate Levels in Shallow TPMWs During the Field Demonstration**

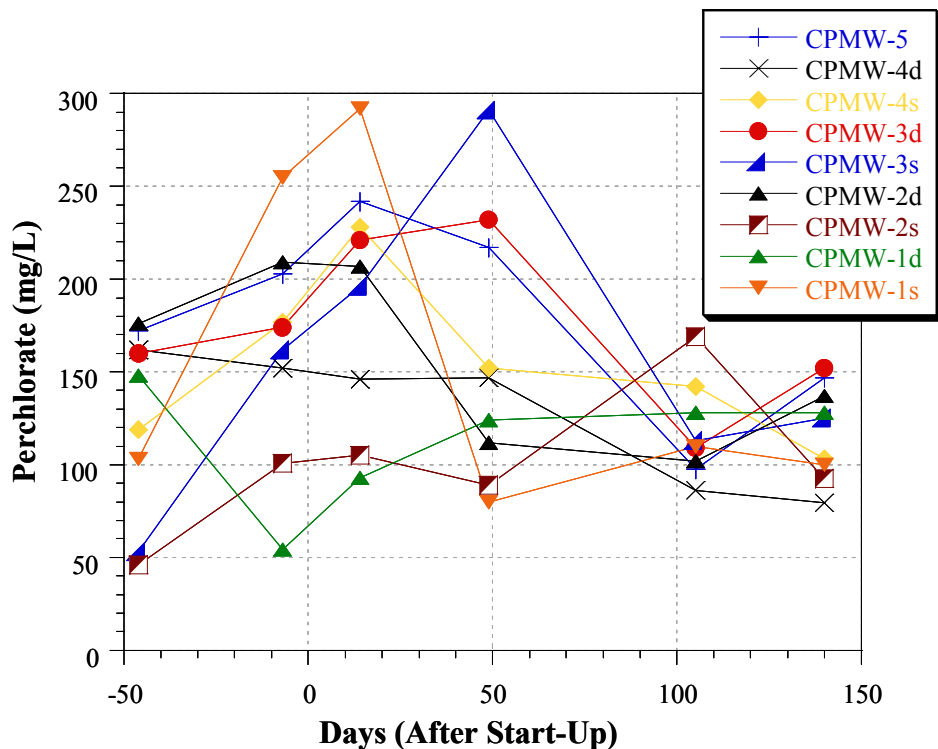
Unlike the test plot, there was no consistent reduction in perchlorate levels in any of the wells in the control plot during the demonstration period (Figure 24 and Table XII). The average perchlorate concentration in the nine CPMWs 69 days prior to system startup was 127 mg/L, and after 140 days of system operation, the concentration was 118 mg/L. A similar amount of water was re-circulated through both plots during the demonstration, but the water in the control plot received no amendments.

**Figure 24. Perchlorate Levels in CPMWs During the Field Demonstration**

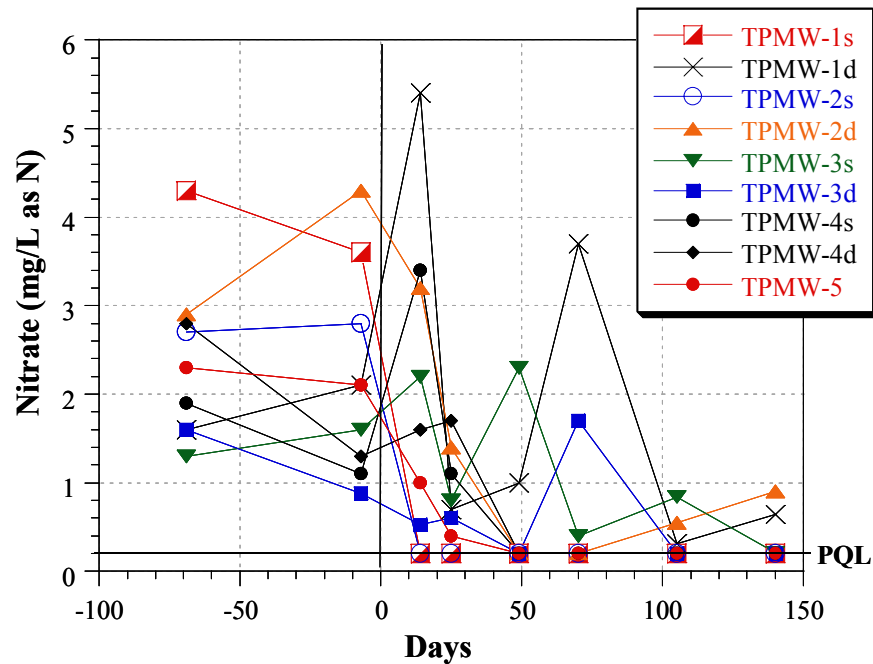
Nitrate and sulfate were measured in groundwater samples by EPA Method 300. The levels of nitrate in the test plot declined rapidly in several wells (Figure 25 and Table XIII). The levels of this contaminant average slightly above 2 mg/L as nitrate-N prior to the investigation in the test plot. Nitrate was below detection (< 0.2 mg/L nitrate-N) in seven of nine TPMWs by day 49 of the study. As noted for perchlorate, TPMW-1d showed the slowest decline in nitrate concentrations. The starting levels of nitrate in the control plot wells were somewhat higher than in the test plot, averaging above 7 mg/L as nitrate-N at the commencement of the study. However, although there was some variability in nitrate levels from point to point in each well,

**Figure 25. Nitrate Levels in the Test Plot During the Field Demonstration**

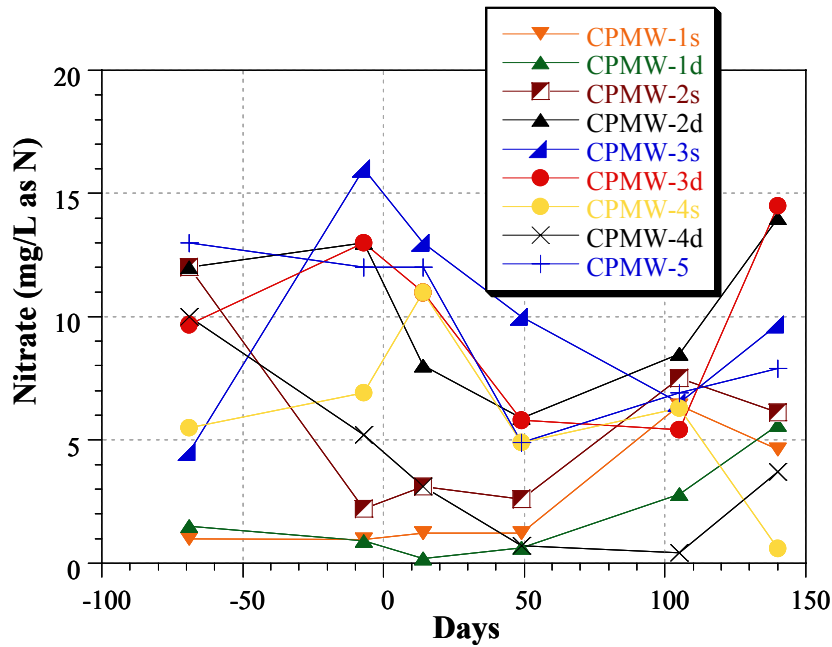
there was no consistent reduction in nitrate levels across the control plot during the demonstration (Figure 26 and Table XIV). After 140 days, the average concentration among the nine wells remained above 7 mg/L as nitrate-N.

**Figure 26. Nitrate Levels in the Control Plot During the Field Demonstration**

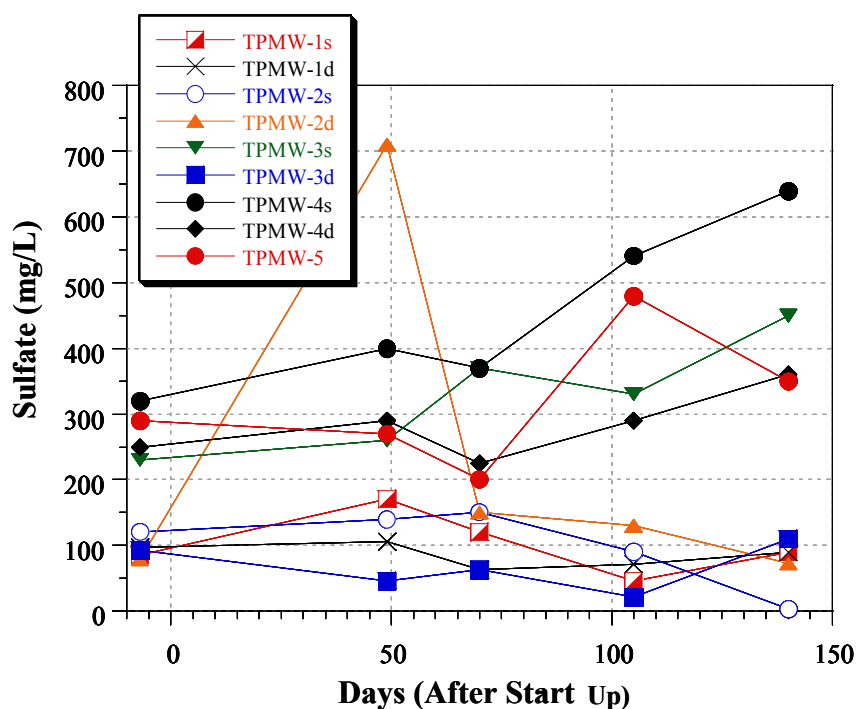
There was a slight odor of hydrogen sulfide detected in some of the test plot wells during the demonstration, and the presence of a black precipitate was observed in a few wells on these occasions (presumably iron sulfide). During the short demonstration time, the goal was to supply adequate electron donor to achieve nitrate and perchlorate reduction, rather than to tightly control the process. If the demonstration were conducted for a longer period, the level of excess electron donor could have been minimized further. However, overall, the level of sulfate reduction in the test plot was not significant based on sulfate measurements (Figure 27 and Tables XV and XVI). The average concentration at the start of the demonstration in the nine TPMWs was 174 mg/L, and at the end of the demonstration the average was 240 mg/L. The only well that showed a significant decrease in sulfate concentration was TPMW-2s, but this was based on one point collected at day 140. Levels were normal at the previous sampling time on day 105.

**Figure 27. Sulfate Levels in the Test Plot During the Field Demonstration**

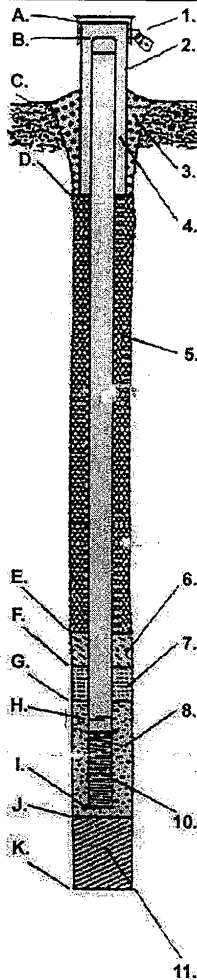
- E. Bentonite seal, top 1.5 ft.  
F. Fine sand, top 3.5 ft.  
G. Filter pack, top 3.5 ft.  
H. Screen joint, top 5 ft  
I. Well bottom 17 ft  
J. Filter pack, bottom 17 ft  
K. Borehole, bottom 17 ft  
L. Borehole, diameter 12.25 in.  
M. O.D. Well casing 6.33 in.  
N. I.D. Well casing 6 in

1. Cap and lock? NO  
2. Protective cover pipe:  
a. Inside diameter: 10 in.  
b. Length: 1 ft.  
c. Material: ALUMINUM Steel ☐  
Other ☒  
d. Additional protection? Yes ☐ No ☒  
If yes, describe \_\_\_\_\_

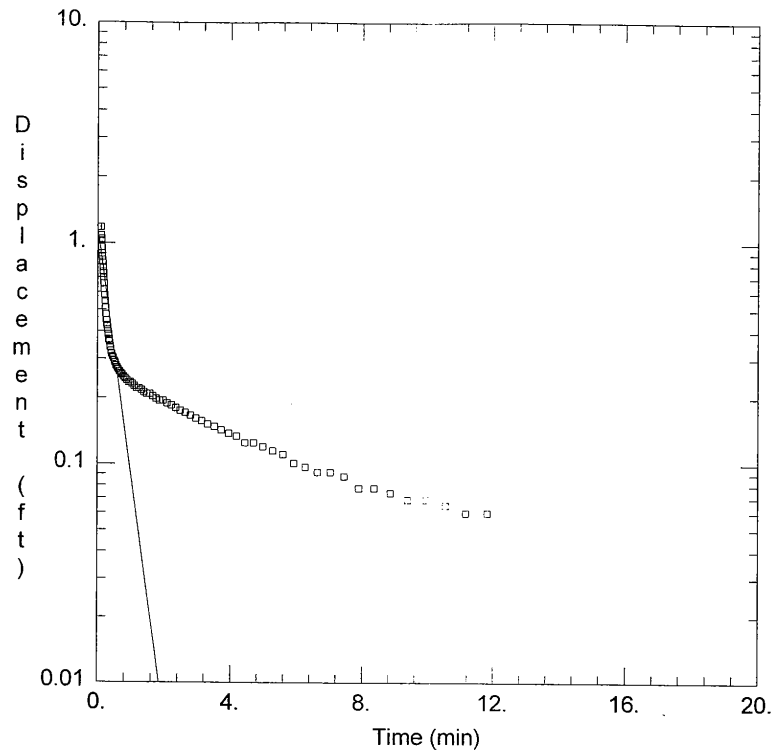
<u>MW-4 RISING HEAD</u>	
Data Set: <u>Q:\APPS\AQTMW4OUT.AQT</u>	
Date: <u>03/07/03</u>	Time: <u>16:25:03</u>
<u>PROJECT INFORMATION</u>	
Test Location: <u>Indian Head, MD</u>	
Test Well: <u>MW-4</u>	
Test Date: <u>2/14/02</u>	
<u>AQUIFER DATA</u>	
Saturated Thickness: <u>11.76</u> ft	Anisotropy Ratio (Kz/Kr): <u>1.</u>
<u>WELL DATA</u>	
Initial Displacement: <u>1.179</u> ft	Water Column Height: <u>11.76</u> ft
Casing Radius: <u>0.086</u> ft	Wellbore Radius: <u>0.344</u> ft
Screen Length: <u>10.</u> ft	Gravel Pack Porosity: <u>0.3</u>
<u>SOLUTION</u>	
Aquifer Model: <u>Unconfined</u>	K = <u>0.01385</u> ft/min
Solution Method: <u>Bouwer-Rice</u>	y0 = <u>1.168</u> ft

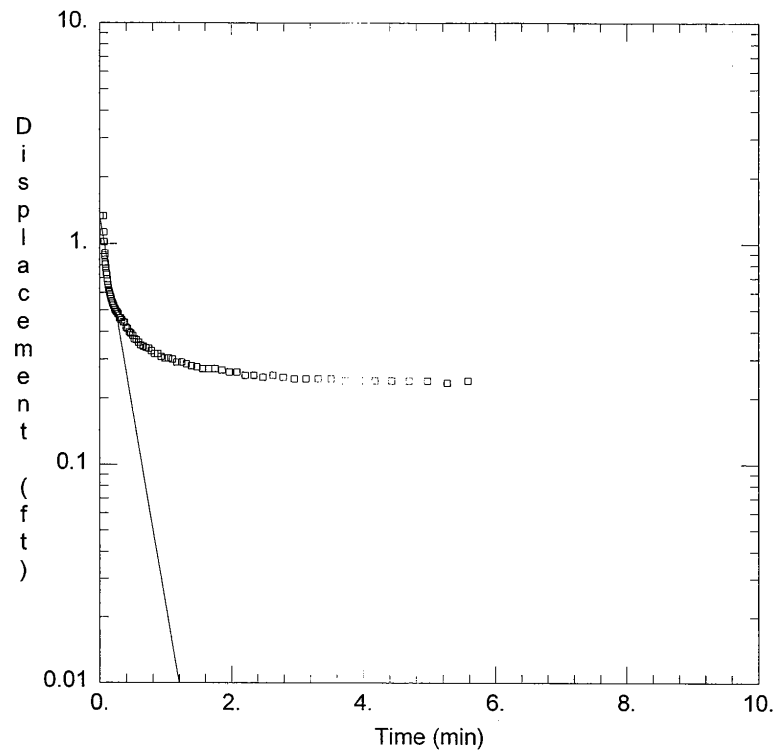
<u>MW-5 RISING HEAD</u>	
Data Set: <u>Q:\APPS\AQTTMMW5OUT.AQT</u>	
Date: <u>03/07/03</u>	Time: <u>16:24:32</u>
<u>PROJECT INFORMATION</u>	
Test Location: <u>Indian Head, MD</u>	
Test Well: <u>MW-5</u>	
Test Date: <u>2/14/02</u>	
<u>AQUIFER DATA</u>	
Saturated Thickness: <u>11. ft</u>	Anisotropy Ratio (Kz/Kr): <u>1.</u>
<u>WELL DATA</u>	
Initial Displacement: <u>1.333 ft</u>	Water Column Height: <u>11. ft</u>
Casing Radius: <u>0.086 ft</u>	Wellbore Radius: <u>0.344 ft</u>
Screen Length: <u>10. ft</u>	Gravel Pack Porosity: <u>0.3</u>
<u>SOLUTION</u>	
Aquifer Model: <u>Unconfined</u>	K = <u>0.02161 ft/min</u>
Solution Method: <u>Bouwer-Rice</u>	y0 = <u>1.335 ft</u>

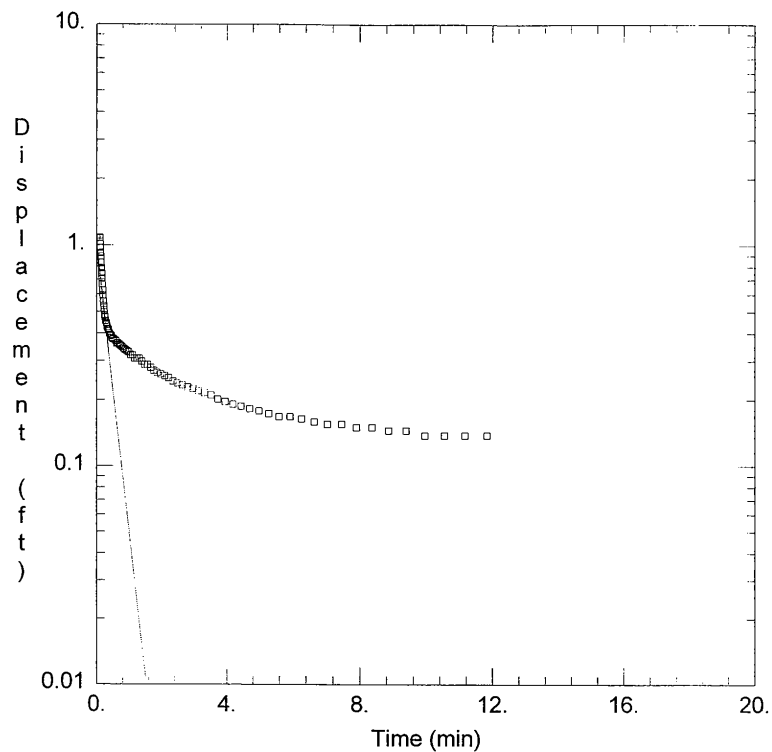
<u>MW-6 RISING HEAD</u>	
Data Set: <u>Q:\APPS\AQTM\MW6OUT.AQT</u>	
Date: <u>03/07/03</u>	Time: <u>16:19:27</u>
<u>PROJECT INFORMATION</u>	
Test Location: <u>Indian Head, MD</u>	
Test Well: <u>MW-6</u>	
Test Date: <u>2/14/02</u>	
<u>AQUIFER DATA</u>	
Saturated Thickness: <u>11.3</u> ft	Anisotropy Ratio (Kz/Kr): <u>1.</u>
<u>WELL DATA</u>	
Initial Displacement: <u>1.082</u> ft	Water Column Height: <u>11.3</u> ft
Casing Radius: <u>0.086</u> ft	Wellbore Radius: <u>0.344</u> ft
Screen Length: <u>10.</u> ft	Gravel Pack Porosity: <u>0.3</u>
<u>SOLUTION</u>	
Aquifer Model: <u>Unconfined</u>	K = <u>0.01613</u> ft/min
Solution Method: <u>Bouwer-Rice</u>	y0 = <u>1.017</u> ft

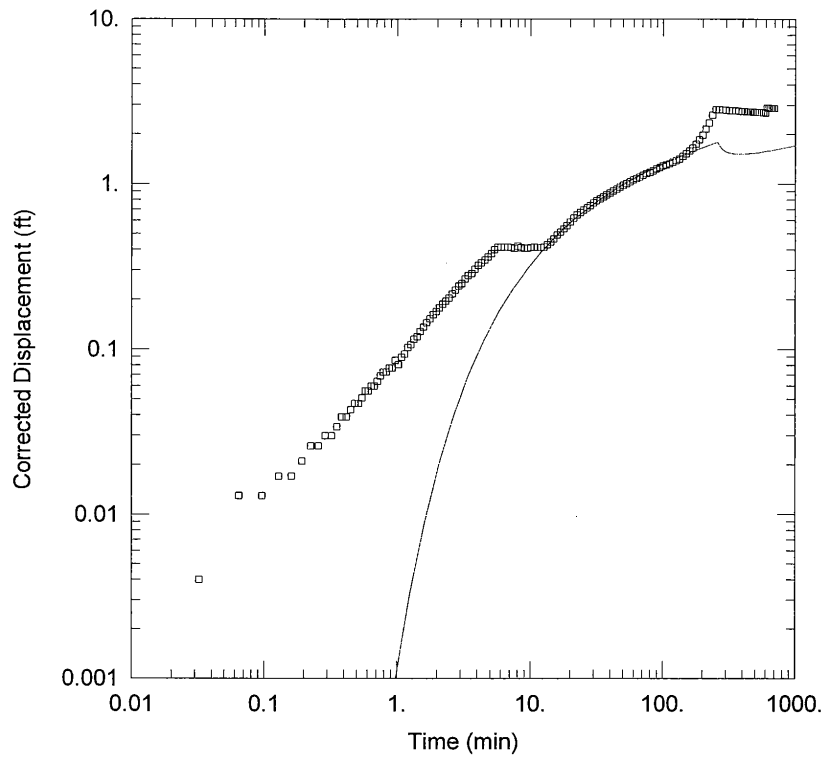
#### WELL TEST ANALYSIS

Data Set: Q:\APPS\AQTW\PTTLR1.AQT

Using this information a 12-hour pump test was conducted. An initial flow rate of approximately 0.2 gal/min was used at the start. However, based on the observed rate of drawdown within the extraction well, which indicated the well would be pumped dry, the flow rate was adjusted down to approximately 0.15 gal/min after approximately 4.5 hours of pumping. This reduction in flow rate stabilized the rate of decline in water level within the extraction well, allowing for continuous pumping throughout the test.

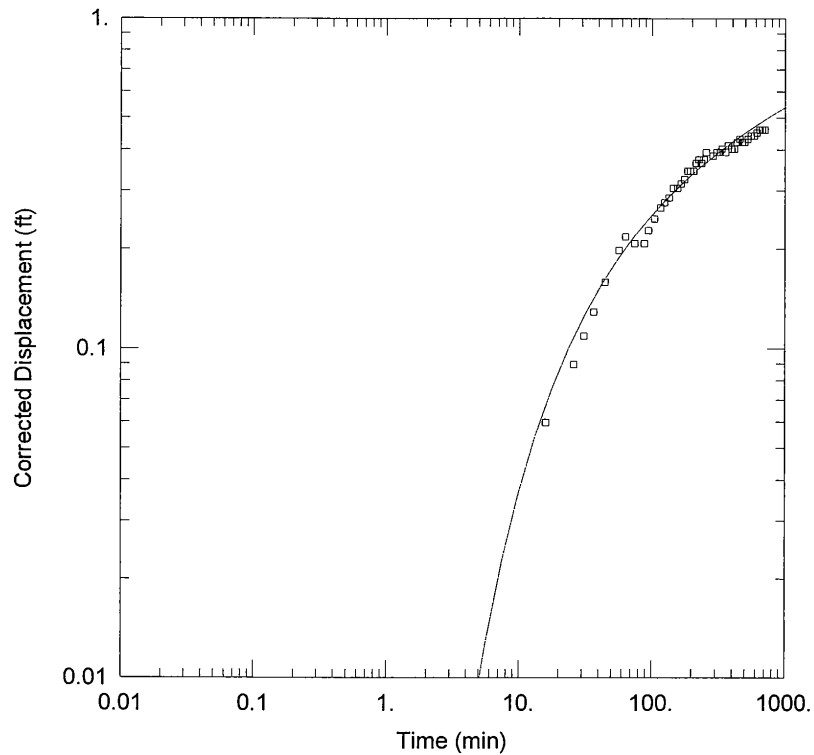
#### WELL TEST ANALYSIS

Data Set: Q:\APPS\AQTW\PMW4.AQT
